**MIAMI-DADE****MUNICIPAL INSPECTION REQUIREMENTS AND RECORD 12/04/2019**

JOB SITE ADDRESS 15550 NW 59 AVE

Re: **Renovation Asbestos Survey Report**  
**Caterpillar Miami Distribution Center**  
**Security Guard House**  
15550 NW 59<sup>th</sup> Avenue  
Miami Lakes, Florida 33014  
PSI Project No.: 07842825

| Job Description: REPLACE EXT STOREFRONT & EXT DOORS |

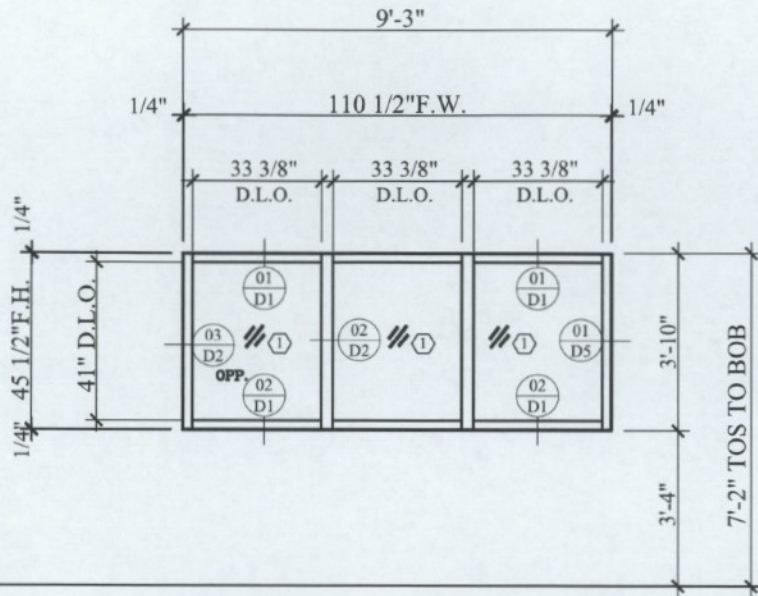
### ELEVATION W1

ALDORA ALUMINUM & GLASS  
PRODUCTS, INC.  
SERIES "FRONT SET" ALUMINUM  
WINDOW WALL SYSTEM-L.M.I.  
NOA:19-0124.06

| WIND PRESSURE |
|---|
| + 42.0 PSF |
| - 54.0 PSF |

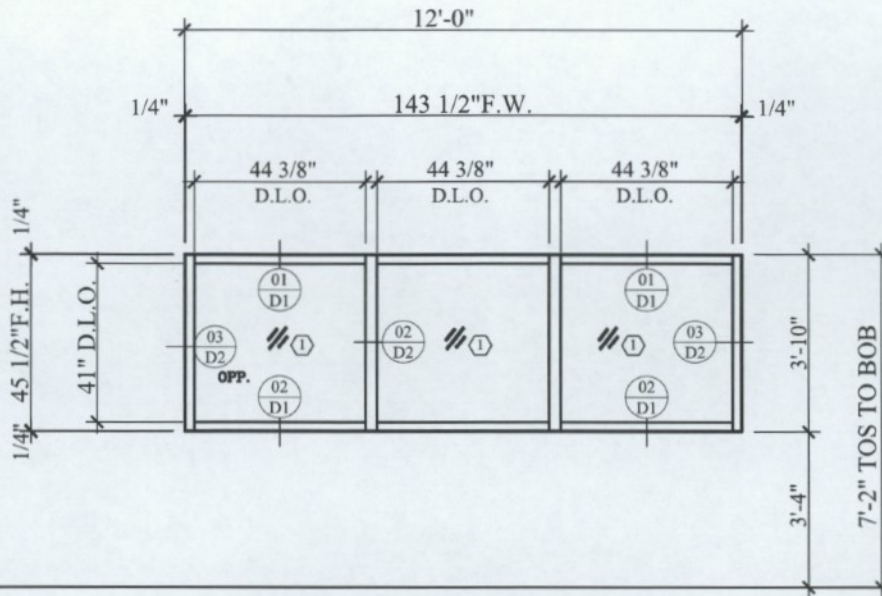
### ELEVATION W2

ALDORA ALUMINUM & GLASS  
PRODUCTS, INC.  
SERIES "FRONT SET" ALUMINUM  
WINDOW WALL SYSTEM-L.M.I.  
NOA:19-0124.06

| WIND PRESSURE |
|---|
| + 42.0 PSF |
| - 54.0 PSF |

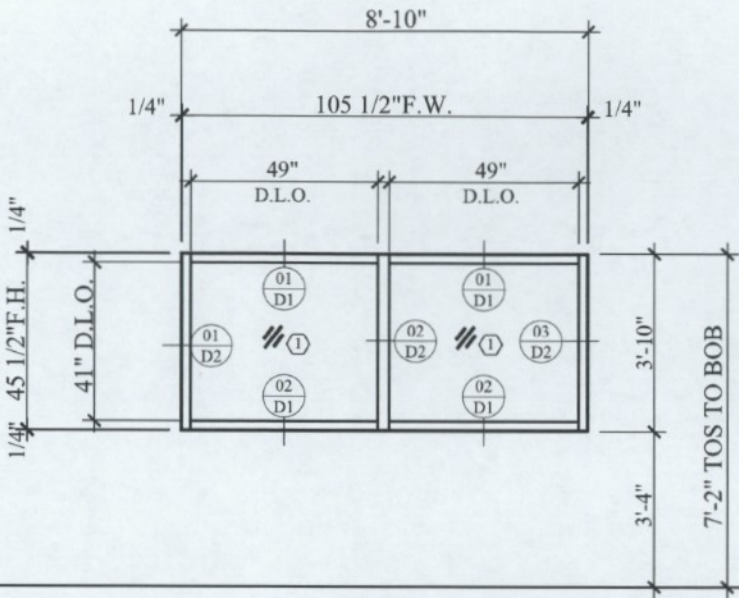
### ELEVATION W3

ALDORA ALUMINUM & GLASS  
PRODUCTS, INC.  
SERIES "FRONT SET" ALUMINUM  
WINDOW WALL SYSTEM-L.M.I.  
NOA:19-0124.06

| WIND PRESSURE |
|---|
| + 42.0 PSF |
| - 54.0 PSF |

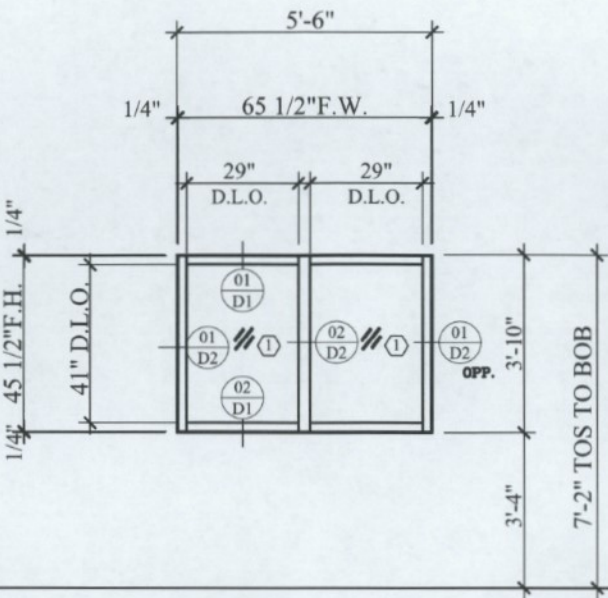
### ELEVATION W4

ALDORA ALUMINUM & GLASS  
PRODUCTS, INC.  
SERIES "FRONT SET" ALUMINUM  
WINDOW WALL SYSTEM-L.M.I.  
NOA:19-0124.06

| WIND PRESSURE |
|---|
| + 42.0 PSF |
| - 54.0 PSF |

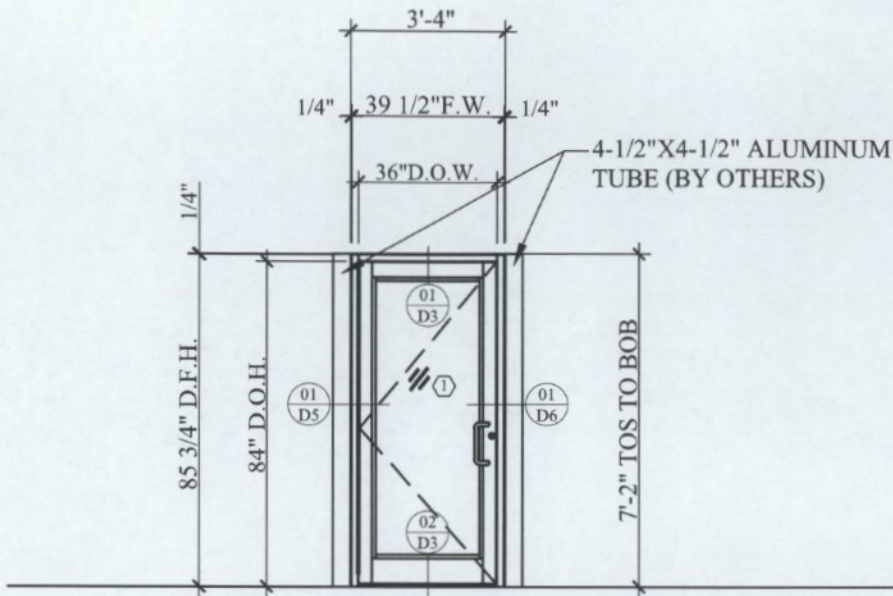
**ELEVATION 100**

DOOR HARDWARE SCHEDULE (100 & 101):  
(DOOR HARDWARE TO COMPLY WITH NOA:17-0926.16)  
-(1) CONTINUOUS ALUMINUM GEARED HINGE, PEMKO FM-SLI  
-(1) THREE POINT LOCK SYSTEM, SERIES 2222, REGENT HARDWARE, RADIUS FACEPLATE, CL FINISH  
-(2) DOOR PULL, 1" ROUND, IVES 8190 EZHD 10"STD  
-(1) OVERHEAD SURFACE MOUNTED LCN 4021 HEAVY DUTY CLOSER  
- (1) ADA THRESHOLD  
(DOORS WITH WATER RESISTANT COMPONENTS APPROVED FOR INSTALLATIONS WHERE WATER INFILTRATION RESISTANCE IS REQUIRED.)

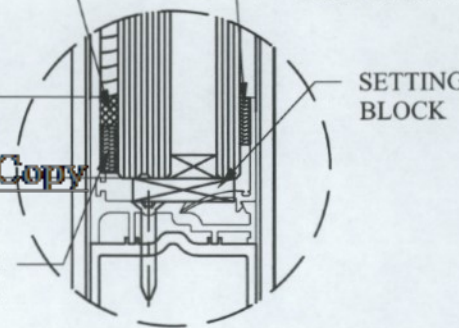
### DETAIL-01

TYP. GLAZING DETAIL  
SERIES "SUMMIT"

ALDORA ALUMINUM & GLASS PRODUCTS, INC.  
SERIES "SUMMIT" ALUMINUM  
ENTRANCE DOOR W/O  
TRANSOM-L.M.I.
